Subject : **PRB-145044 – Error code 0040000**  
To : **Integrators/Final customers**

**ERROR CODE = 00400000 or  
E4000000  
VIP400/410 used on RM6  
Ring Main Unit for MT network  
3-24 kV, class AA10-AA20**

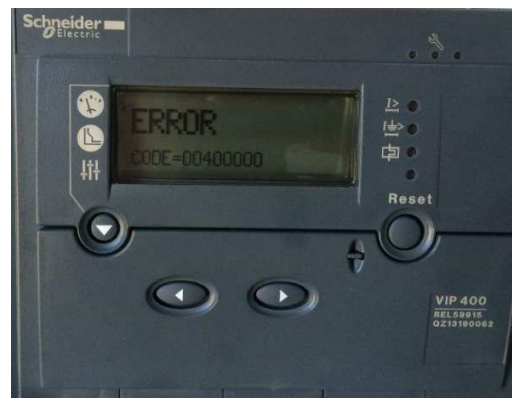
Schneider Electric has identified the possibility of a degraded operation for certain VIP400 and VIP410 (concerned references REL59915, REL59916 and REL59917) which may switch on, in flashing mode, the

indicator and display the error code 00400000/E4000000. This error code could be cleared by using the 'reset' push button, however it will reappear periodically.

According to user manual (NRJED311206FR), this error code indicates that the maximum number of writing in EEPROM memory is reached and that information related to trip events is no more registered in EEPROM memory.

The mentioned issue is linked to events recording backup procedure. It needs some particular conditions to happen: if several events occur over a very short period and are followed by a shut down of the power supply of the relay, an infinite loop may occur and write a value in EEPROM every 30 sec at the next power up. After a period of approximately one year the maximum number of writes of the EEPROM memory is reached and the error message is displayed. If the product is not powered continuously, the onset of the phenomenon will be delayed in proportion.

During the tests it is advised to supply the product for one minute before creating an event.

This defect is resolved in products manufactured since mid April 2015 with firmware V2.04 and higher.

**In case the problem would appear in your installation, please contact your local Customer Care Center to arrange the update of the firmware of concerned VIP400 / 410.**
