**DATE:** August 18, 2023.  
**TO:** Users of ATS480 soft starters.  
**FROM:** Schneider Electric Drives Activity.  
**SUBJECT:** ATS480 Manual Modification

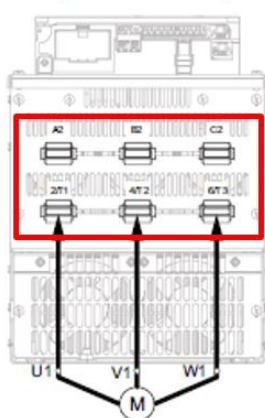
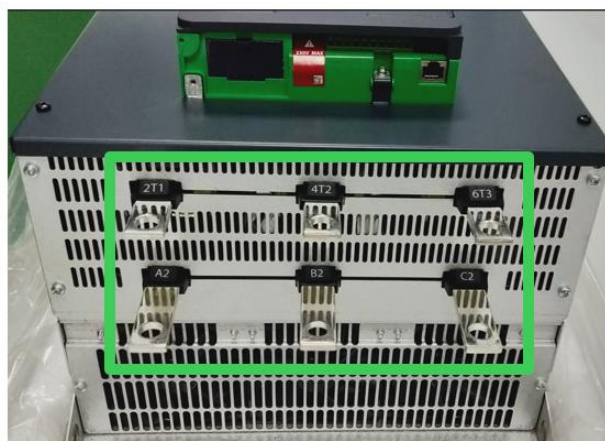
**Wrong representation (bottom view)**

The error concerns the power terminals representation of the bottom part of the ATS480:  
 2/T1, 4/T2, 6/T3 outputs to motor have been reversed with A2, B2, C2 Soft Starter Bypass. If the user connects the wrong wire to the wrong terminal, the equipment will not work.

For any on-going or future design and manufacturing of bus bars to connect terminals of the soft starter to by-pass contactor, use the correct representation shared in the most updated manual (**NNZ85515.04**).
