## Title : Return "invalid file" error after importing CID file into IEDCT

Why IEC61850 module configuration tool (IEDCT) will return "Invalid file" error after importing 3<sup>rd</sup> party device CID/SCD files?

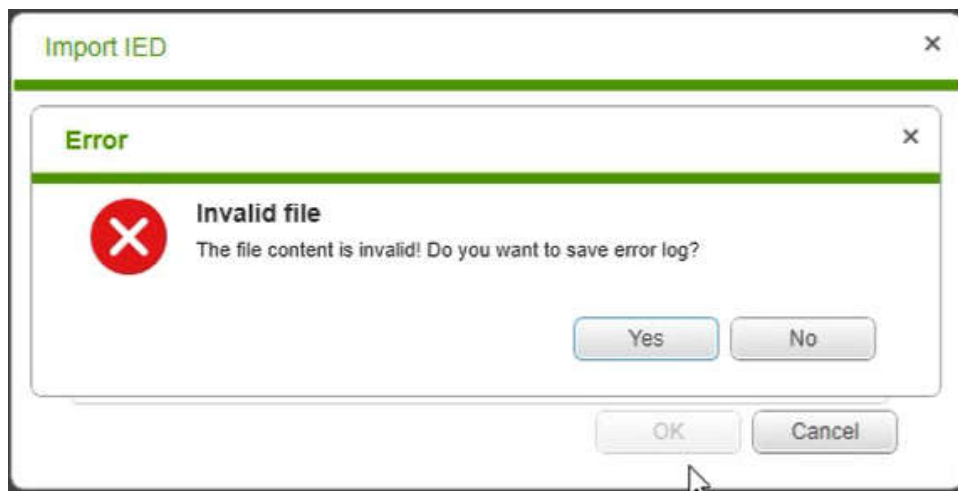
For preventing unexpected behavior caused by invalid configuration file, IEDCT will pop-up an error message and generate an error log files after detecting mistake from CID/SCD files. (see below as example).

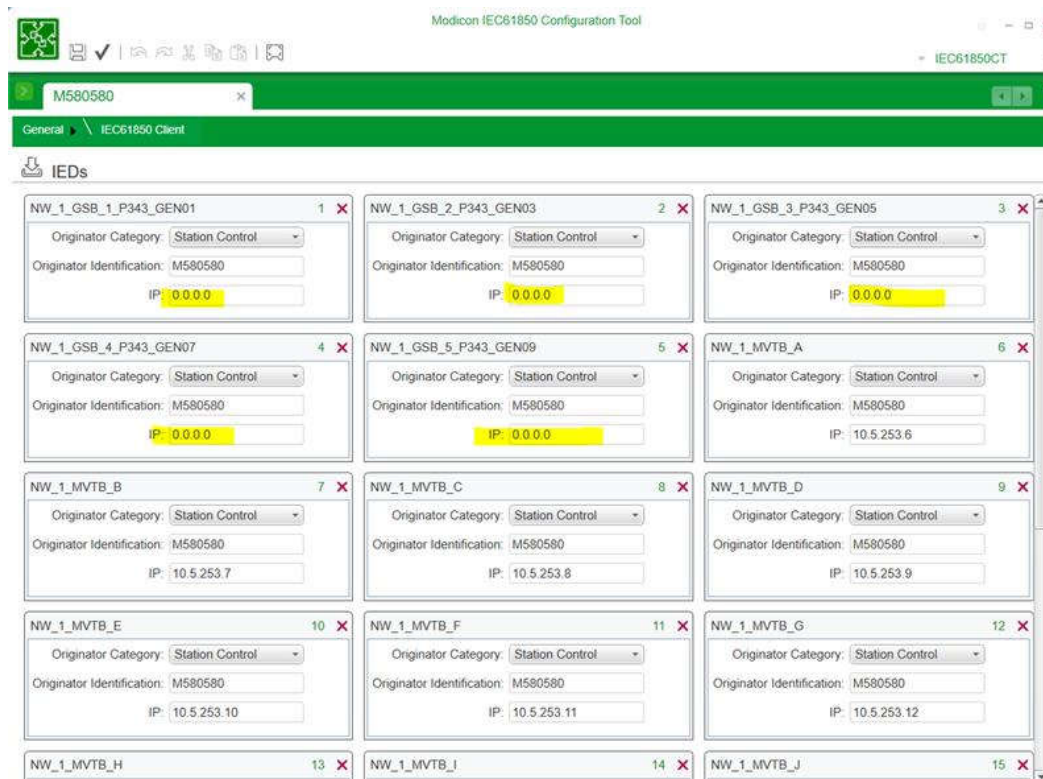
### 1.1 IP Address 0.0.0.0 issue (PEP0620530R)

**Analysis:** Sometimes customer is setting the IP address of the Client IED on the BMENOP0300 at 0.0.0.0

This IP address must not be set on a client IED inside the Configurator Tool because it's causing some delay on GI answering and on sending report by DataChange.

**Resolution:** It's caused by abnormal parameters. Customer must not set the IP address at 0.0.0.0. (see below)

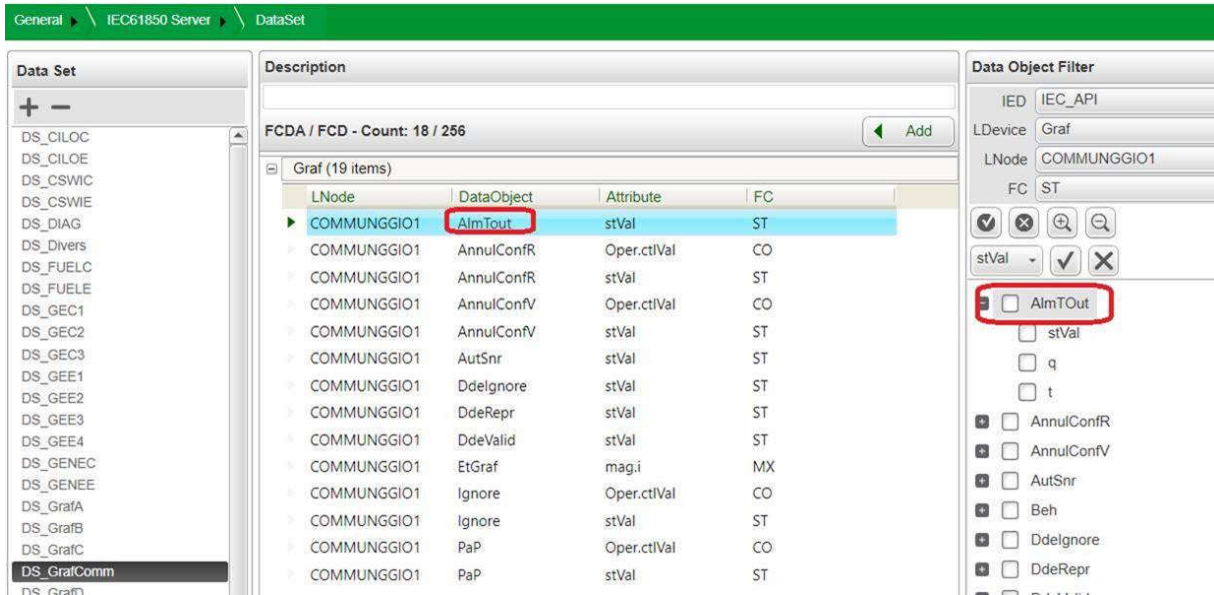
## 1.2 Not all variables are present in IEDCT(PEP0611254R)

**Analysis:** Customers raised some issues regarding NOP server report function not working properly. Some variables are not presented in IEDCT after importing CID files. In this case, it is caused by capital/lowercase letter issue. In deeply analyze their CID file, there is "Alm<sub>out</sub>" DO in "DS\_GrafComm" Data set but "Alm<sub>Out</sub>" in Data Model (see below). Similar mistake found in lots places in their CID file. IEDCT will lost these parameters due to different name (case sensitive)

e.g. This is the "DS\_GrafComm" dataset definition in cid, the fourth line "AlmTout" is illegal, so it cannot be shown in IEDScout screen.

**Resolution:** It's caused by invalid CID files. Customer must make sure the object name in whole CID/SCD file should keep consistency. IEDCT is case sensitive tool and recommended customer to check and fix similar mistakes in their CID/SCD files.

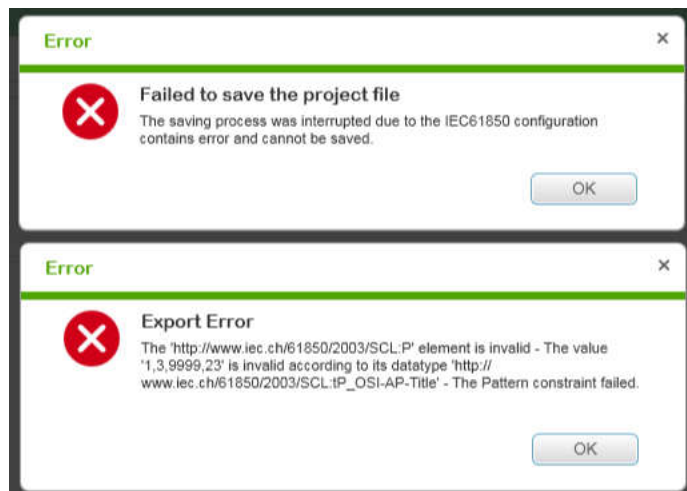
### 1.4 CID file error at import in IEDCT v3.0 IR6

**Analysis:** Customer cannot save project after importing 3rd part CID file into IEDCT, it will pop-up below issue/message.

According to error message above, IEDCT parser cannot support certain element when apply this datatype.

**Resolution:** It's caused by unsupported attribute. Remove this "OSI-AP-Title" title from CID file according to error message.

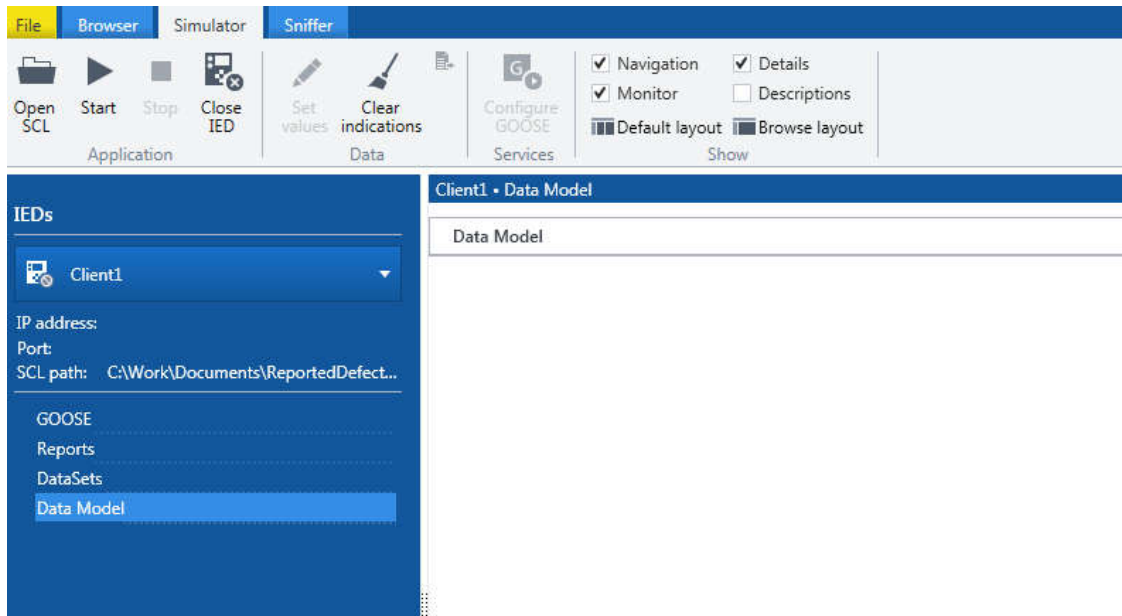
### 1.5 Returns invalid file error after importing AB CID file (PEP0628898R)

**Analysis:** End user applied their private namespace which IEDCT cannot recognize.

One way we can check this issue is through IEDScout. We can see that after importing the customer's cid into IEDScout, the Data Model, Dataset, Reports, Goose are all empty:

So user can use IEDScout to verify their CID file firstly.

**Resolution:** It's caused by CID not following standard and used private namespace. Removing these elements can solve this issue.
