Wrong operation situation of the Directional Phase Over-current:

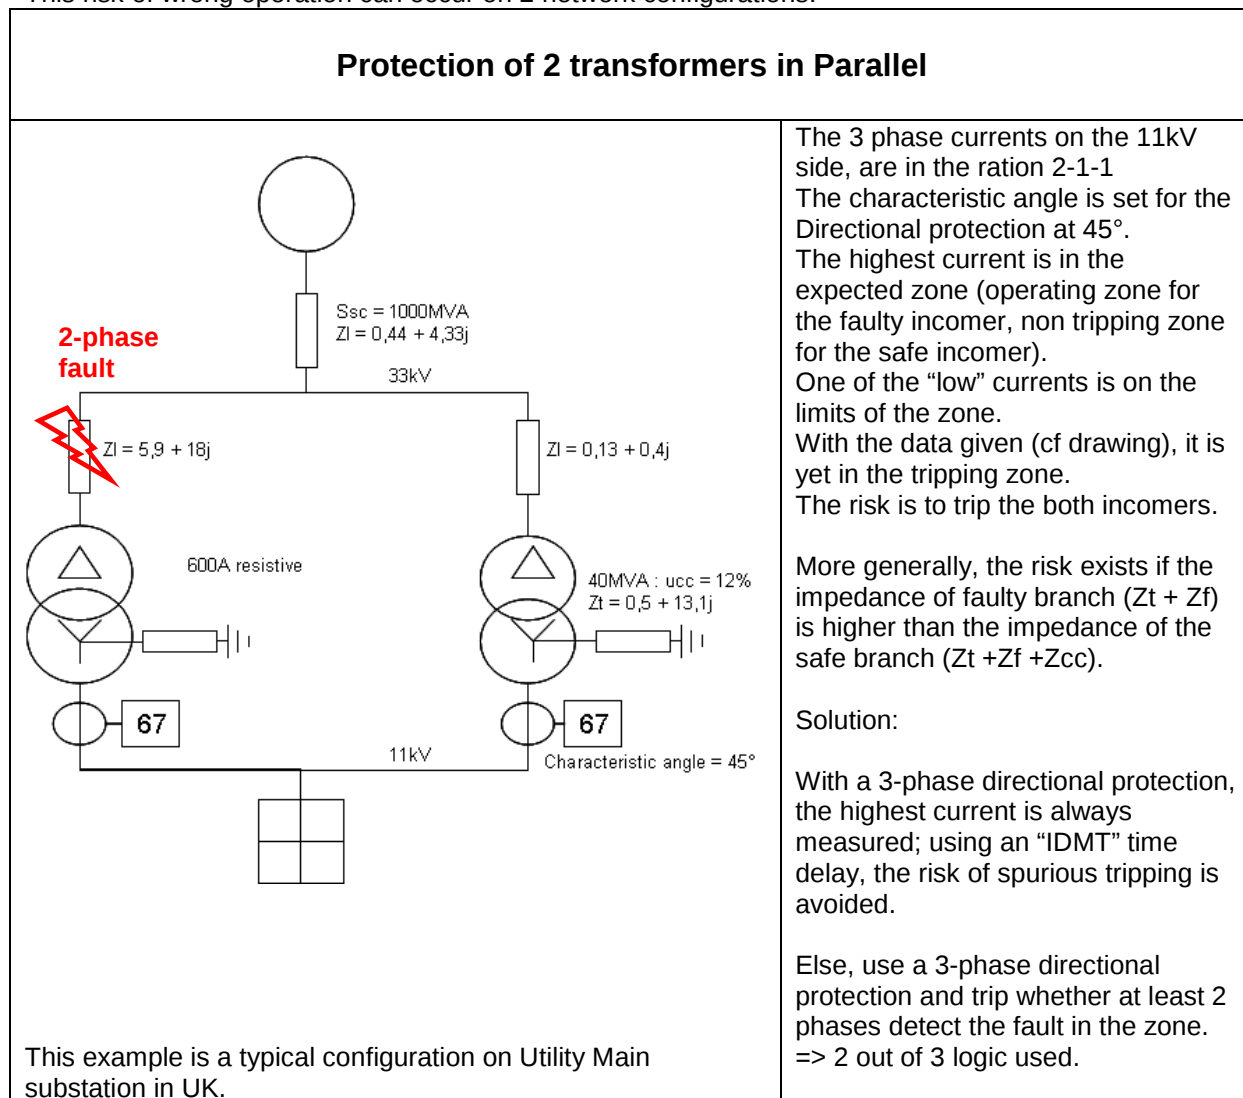
With such a setting, it exists a risk of non detection or/and unwanted tripping: detection of a fault on the opposite side of a transformer Yd or Dy.

This risk of wrong operation can occur on 2 network configurations:

This example is a typical configuration on Utility Main substation in UK.

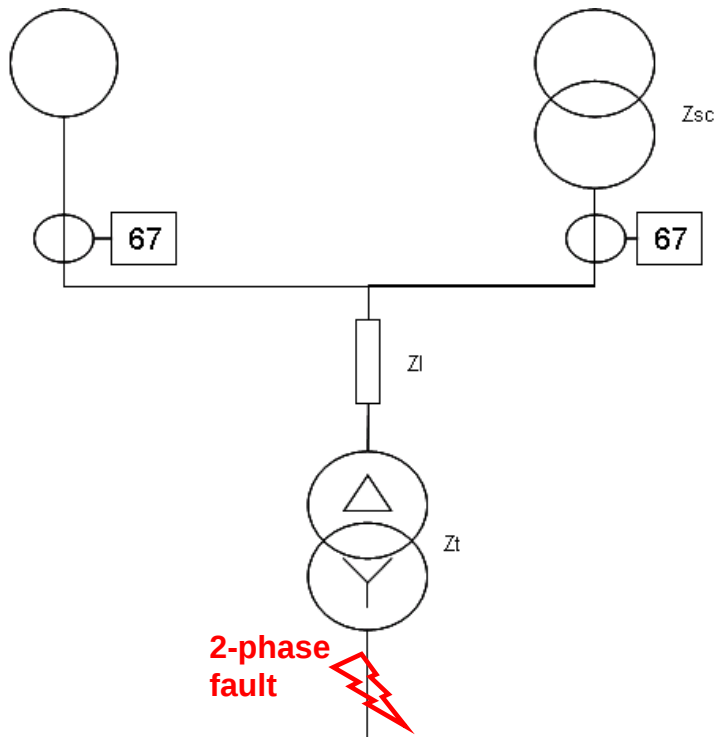
## Protection of 2 Incomers

This fault is quite similar from the previous one.  
Only the values change.

The 3 currents seen by the directional protection are in the ratio 2-1-1.

One of the "low" currents is in the wrong zone, whether the impedance of the faulty branch ( $Z_t + Z_l$ ) is higher than the short-circuit impedance, which is often the case.

Consequence : spurious tripping of one or both incomers.

Set up the threshold of the directional higher than the 2-phase short-circuit current at the secondary side.

Else, set up the angle at  $30^\circ$ .

Else more, use a 3-phase directional protection and trip if 2phases at least are detecting the fault in the zone.
