In the setting of 60FL, VT supervision, what would be the consequence of setting Non-directional and Inhibition setting for 67 and 67N protections?

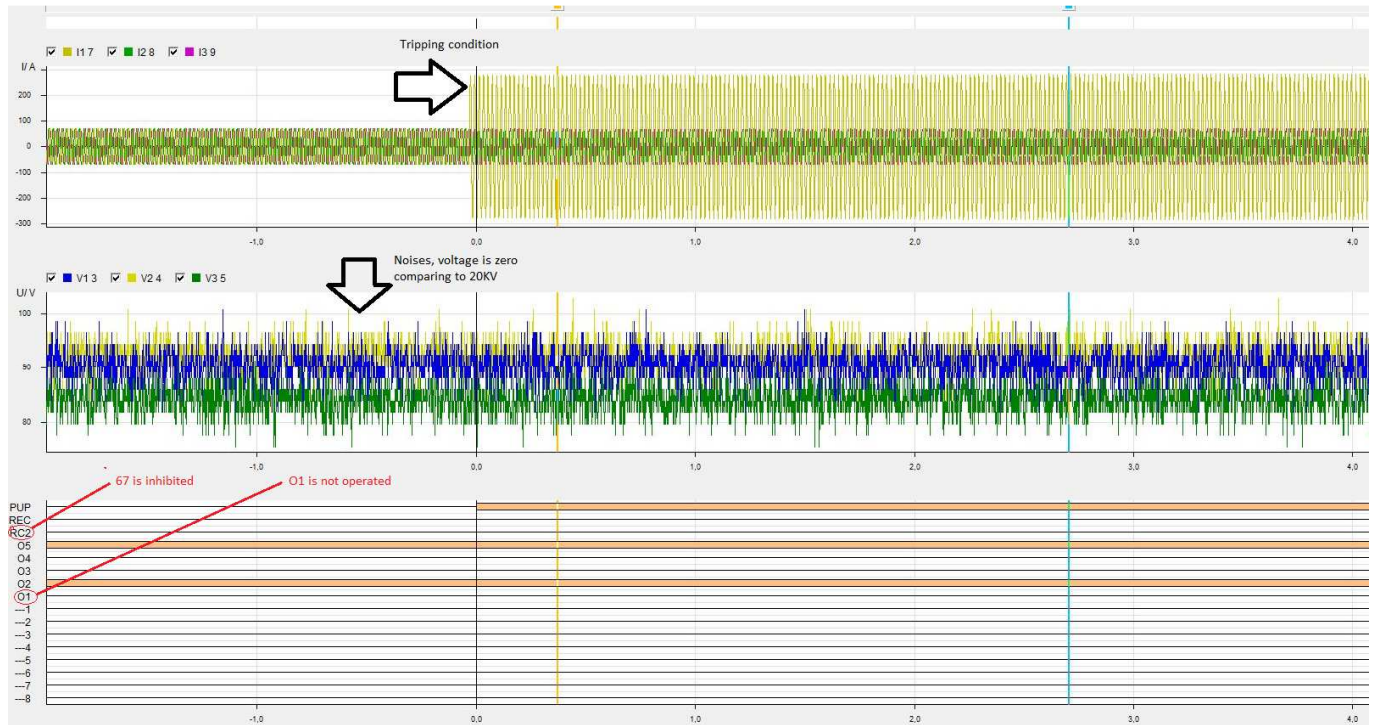
The following data is highlighted in Figure No.8:

- Tripping condition
- Voltage injection is zero (some noise, but comparing to nominal voltage 20KV is nothing)
- 67 directional protection inhibited – REC2 signal (Pup for 67) is not operated
- O1 as general trip output is not operated

So as it is clear on Figure No.8 the relay did not operate and 67 directional protection is inhibited.

Although we have pick up signal in disturbance recording, but to make it clearer the P67-1-1 which is instantaneous output (pick-up) signal of directional protection is assigned to REC2. It is reported in all disturbance recordings.

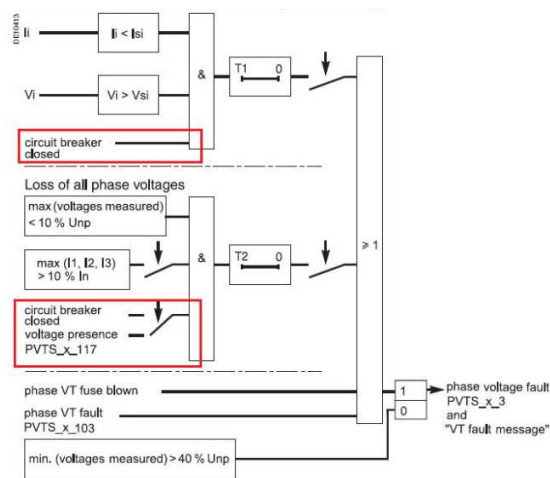
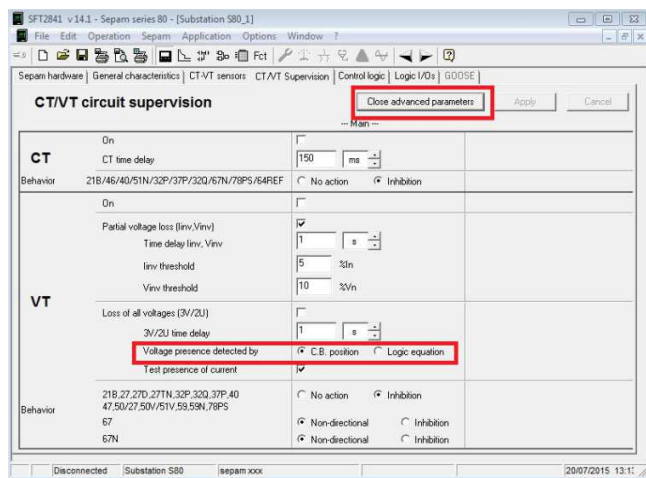
As mentioned in VT supervision block diagram, and also in setting page in SFT2841, it is important to have CB position to detect voltage presence. Just make it simple, if we set this parameter to CB position, it means that VT supervision is working when CB is closed. Or if this parameter is set to Logic equation, then correct defined logic should be used to set PVTS_X_117 variable in adequate state representing voltage presence. AEDL3
