## PacDrive™ Sercos Firmware-Assistent V2.0 -> V2.6

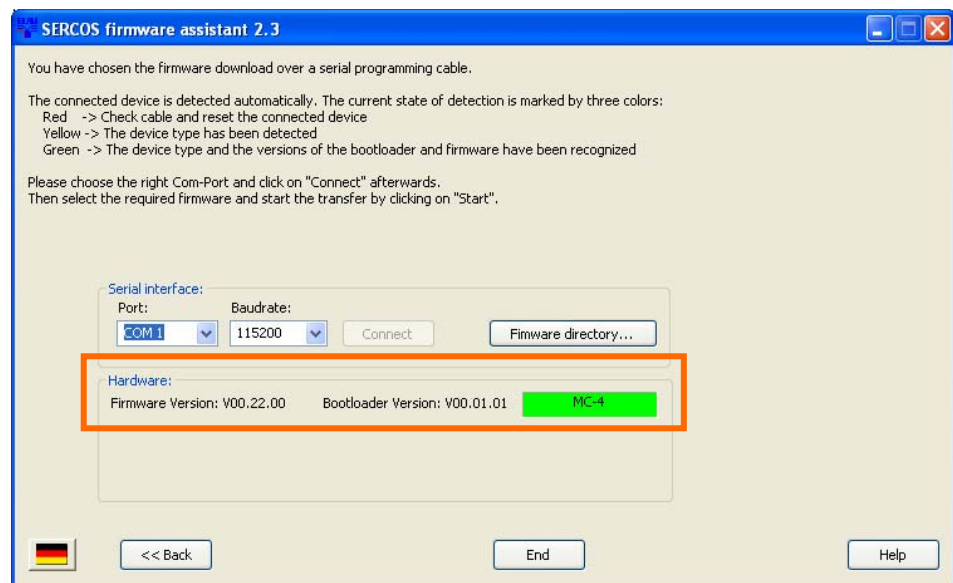
Fig. 1 The actual state of device detection is shown in the "Hardware" area

During this time, the serial interface cable can be connected to a device and disconnected again. The detection takes place in three color-coded steps. The actual state is shown in the "Hardware" area (see Fig. 1):

| Color | Meaning |
|---|---|
| Green | Firmware and bootloader versions were detected and are shown in the "Hardware" area (see Fig. 1). The firmware download is possible without any restrictions. |

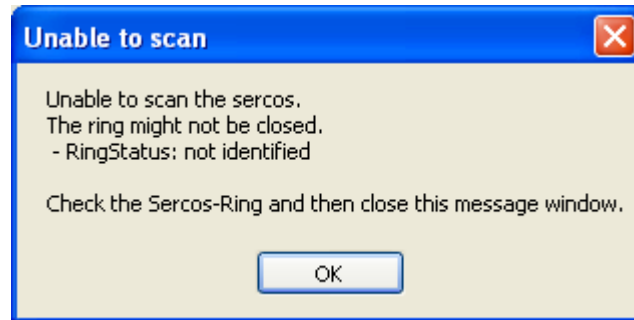
Fig. 4 Errors are shown before scanning

**SCR 3799** Before scanning the Sercos bus for devices, the SERCOS ring is checked. Possible errors and information on how to solve them is shown in a message window (see Fig. 4).

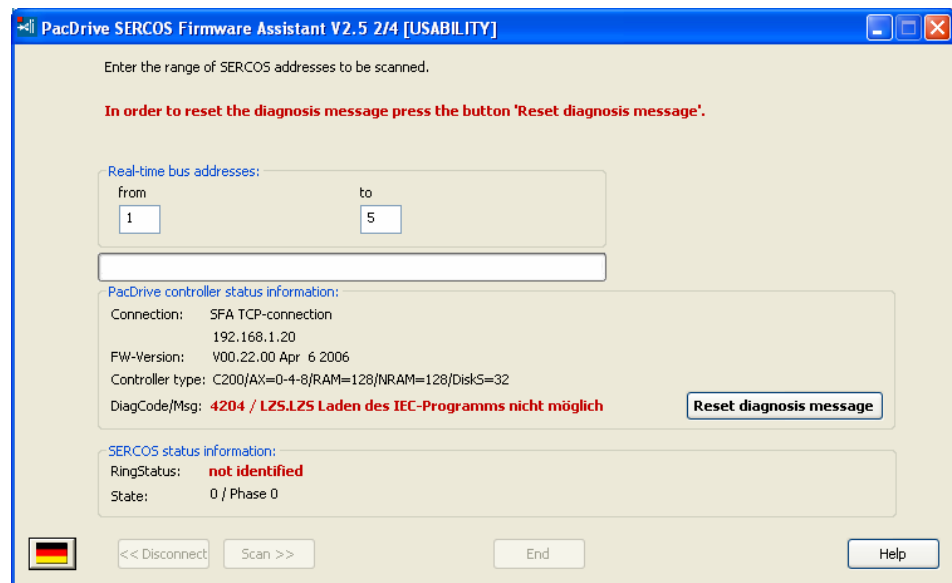
Fig 6 In the bottom window SERCOS-Scan the diagnosis messages are displayed in red and extra bold type.

**SCR 4998** The operator guidance inside the rear side of the SERCOS-Scan shows the current status of the SERCOS-Ring and the diagnosis message. Errors are displayed in red and extra bold type. In the top area information is given for error deletion.

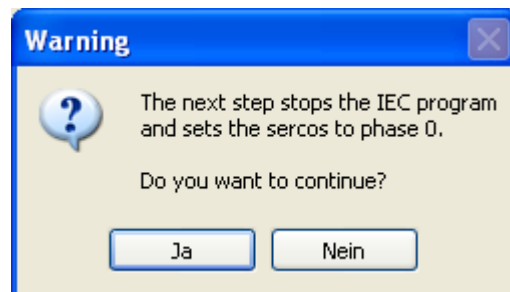
Fig 7 Before calling the rear side „SERCOS-Scan“, the IEC-Program is stopped and SERCOS is set to phase 0.

Before calling the rear side of the SERCOS Firmware Assistant, the controller is stopped and SERCOS set to phase 0. The user has to confirm this in the previous step via the information dialog.

The scan itself can only be performed if the RingStatus displays „OK“.
